Flood Control Project Maintenance
2016 Structure Summary Report
Overall Unit and Item Ratings

Plumas County

North Fork Feather River Diversion Channel Drop Structure No. 1

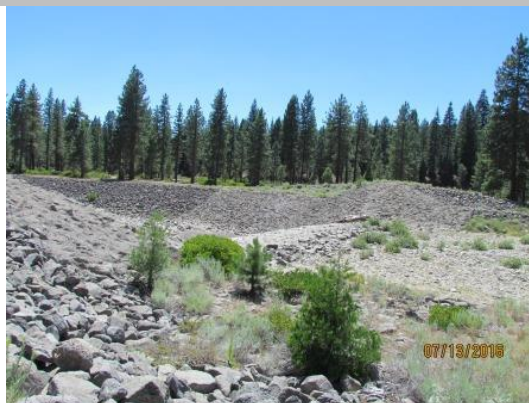
Photo 1 of 2 : ST_2016_NA0015_57_23_20160729_00003.jpg

LM Start	0.00	Rating **	N	Issue No.	23
LM End	0.00	Issue Type +	Ma	Location *	
Category	Structures & Concrete Lined Channels			GPS Latitude/Longitude	
				Start	End
Item	Photo Documentation			40.299243 °	40.299243 °
				-121.262034 °	-121.262034 °
DWR ID	DWR_NA0015_57_t_2012_23				
Action/Comments					
Inspector Comments: Spray or remove all vegetation from the channel.

View of drop structure 2, looking towards drop structure 1.

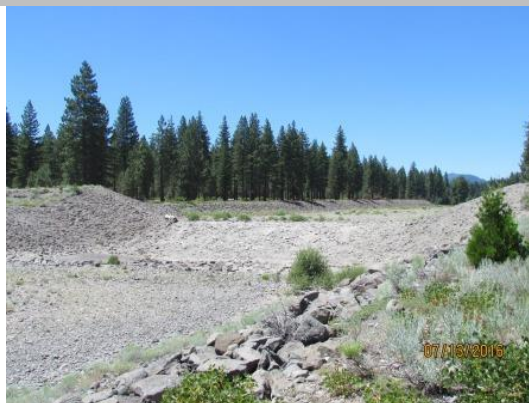
Photo 2 of 2 : ST_2016_NA0015_57_23_20160729_00002.jpg

View of drop structure 1, looking towards the North Fork Feather River.

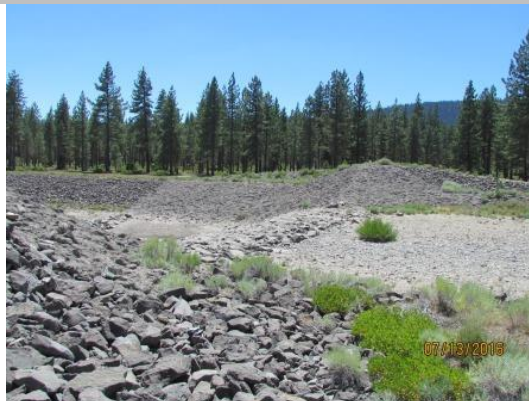
Photo 1 of 2 : ST_2016_NA0015_58_23_20160729_00003.jpg

LM Start	0.00	Rating **	N	Issue No.	23
LM End	0.00	Issue Type +	Ma	Location *	
Category	Structures & Concrete Lined Channels			GPS Latitude/Longitude	
				Start	End
Item	Photo Documentation			40.294270 °	40.294270 °
				-121.258935 °	-121.258935 °
DWR ID	DWR_NA0015_58_t_2012_23				
Action/Comments					
Inspector Comments: Spray or remove all vegetation from the channel.

View of drop structure 2, looking towards drop structure 3.

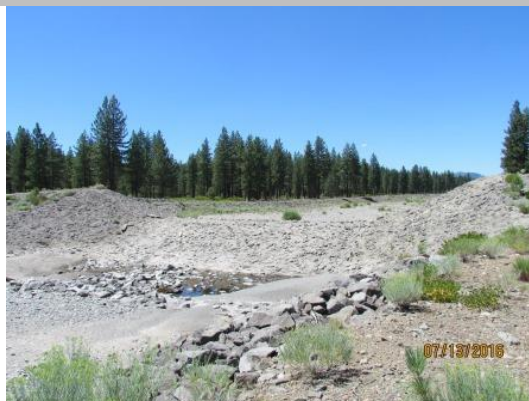
Photo 2 of 2 : ST_2016_NA0015_58_23_20160729_00002.jpg

View of drop structure 2, looking towards drop structure 1.

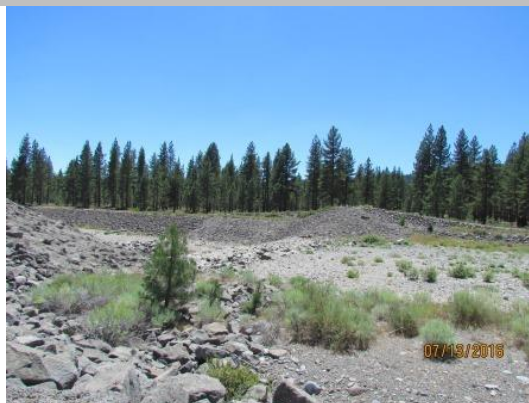
Photo 1 of 2 : ST_2016_NA0015_59_23_20160729_00003.jpg

LM Start	0.00	Rating **	N	Issue No.	23
LM End		Issue Type +	Ma	Location *	
Category	Structures & Concrete Lined Channels			GPS Latitude/Longitude	
				Start	End
Item	Photo Documentation			40.289767 °	40.289767 °
				-121.256375 °	-121.256375 °
DWR ID	DWR_NA0015_59_t_2012_23				
Action/Comments					
Inspector Comments: Spray or remove all vegetation from the channel.

View of drop structure 3, looking towards drop structure 4.

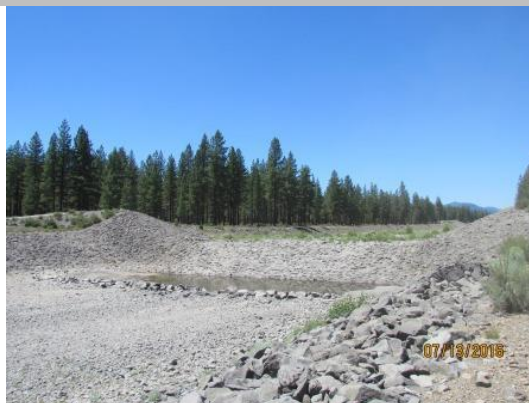
Photo 2 of 2 : ST_2016_NA0015_59_23_20160729_00002.jpg

View of drop structure 3, looking towards drop structure 2.

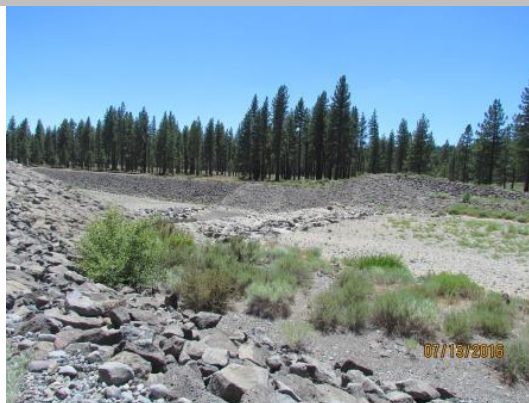
Photo 1 of 2 : ST_2016_NA0015_60_23_20160729_00003.jpg

LM Start	0.00	Rating **	N	Issue No.	23
LM End	0.00	Issue Type +	Ma	Location *	
Category	Structures & Concrete Lined Channels			GPS Latitude/Longitude	
				Start	End
Item	Photo Documentation			40.285653 °	40.285653 °
				-121.253902 °	-121.253902 °
DWR ID	DWR_NA0015_60_t_2012_23				
Action/Comments					
Inspector Comments: Spray or remove all vegetation from the channel.

View of drop structure 4, looking back at drop structure 5.

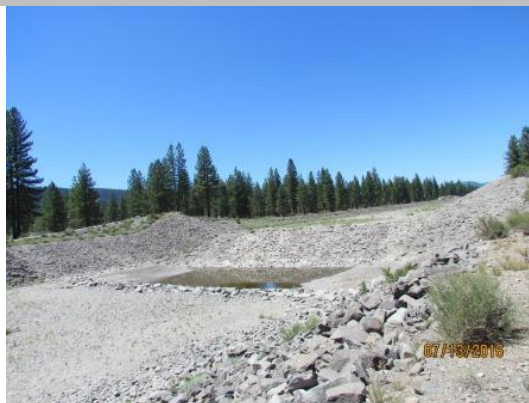
Photo 2 of 2 : ST_2016_NA0015_60_23_20160729_00002.jpg

View of drop structure 4, looking back at drop structure 3.

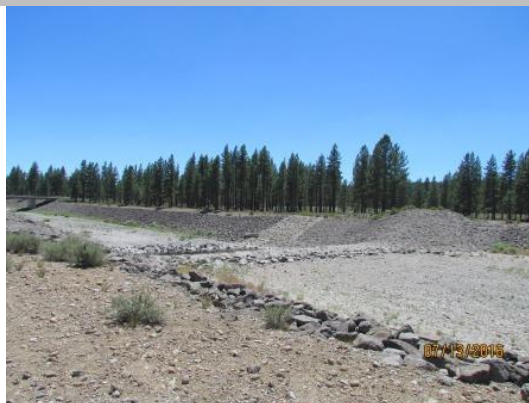
Photo 1 of 2 : ST_2016_NA0015_61_23_20160729_00003.jpg

LM Start	0.00	Rating **	N	Issue No.	23
LM End	0.00	Issue Type +	Ma	Location *	
Category	Structures & Concrete Lined Channels			GPS Latitude/Longitude	
				Start	End
Item	Photo Documentation			40.283028 °	40.283028 °
				-121.252348 °	-121.252348 °
DWR ID	DWR_NA0015_61_t_2012_23				
Action/Comments					
Inspector Comments: Spray or remove all vegetation from the channel.

View of the drop structure 5, Look towards drop structure 6.

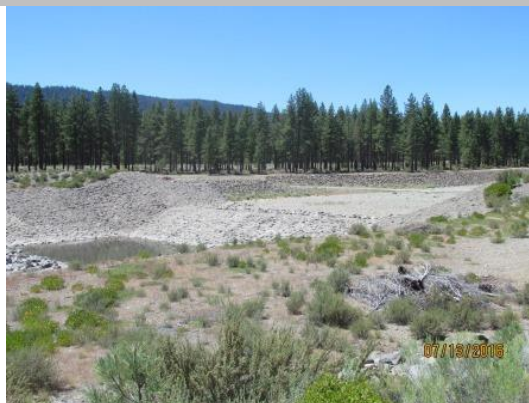
Photo 2 of 2 : ST_2016_NA0015_61_23_20160729_00002.jpg

View of the drop structure 5, Look towards drop structure 4.

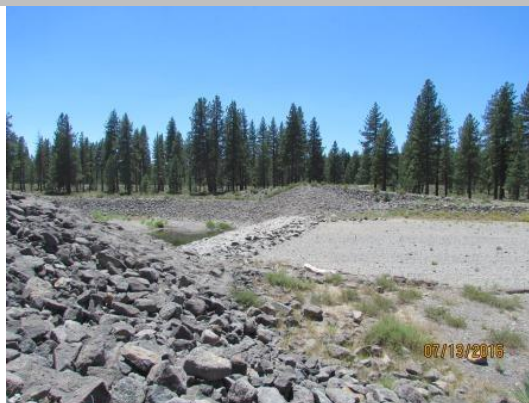
Photo 1 of 2 : ST_2016_NA0015_62_23_20160729_00003.jpg

LM Start	0.00	Rating **	N	Issue No.	23
LM End	0.00	Issue Type +	Ma	Location *	
Category	Structures & Concrete Lined Channels			GPS Latitude/Longitude	
				Start	End
Item	Photo Documentation			40.275902 °	40.275902 °
				-121.248142 °	-121.248142 °
DWR ID	DWR_NA0015_62_t_2012_23				
Action/Comments					
Inspector Comments: Spray or remove all vegetation from the channel.

View of drop structure 6, looking towards drop structure 7.

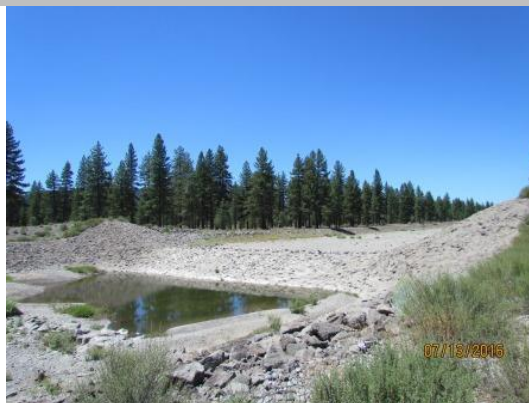
Photo 2 of 2 : ST_2016_NA0015_62_23_20160729_00002.jpg

View of drop structure 6, looking towards drop structure 5.

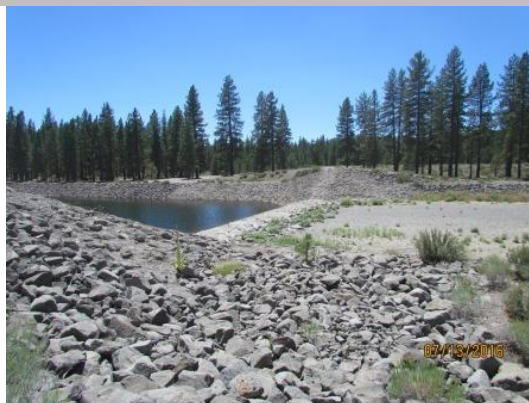
Photo 1 of 2 : ST_2016_NA0015_63_23_20160729_00004.jpg

LM Start	0.00	Rating **	N	Issue No.	23
LM End	0.00	Issue Type +	Ma	Location *	
Category	Structures & Concrete Lined Channels			GPS Latitude/Longitude	
				Start	End
Item	Photo Documentation			40.272544 °	40.272544 °
				-121.246161 °	-121.246161 °
DWR ID	DWR_NA0015_63_t_2015_23				
Action/Comments					
Inspector Comments: Plumas Co. is removing all vegetation from the channel.

View of drop structure 7, looking back towards the lake.

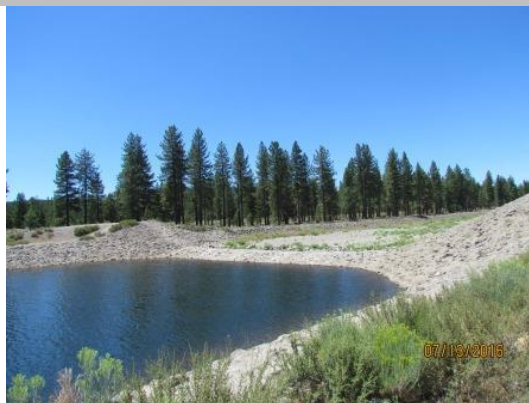
Photo 2 of 2 : ST_2016_NA0015_63_23_20160729_00003.jpg

View of drop structure 7, looking back towards drop structure 6.

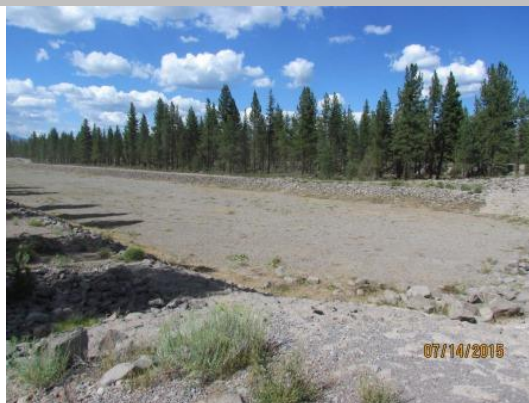
Photo 1 of 1 : ST_2016_NA0015_63_1_20160615_00001.jpg

LM Start	0.00	Rating **	A	Issue No.	1
LM End	0.00	Issue Type +	Ma	Location *	
Category	Structures & Concrete Lined Channels			GPS Latitude/Longitude	
				Start	End
Item	Vegetation & Obstructions			40.272544 °	40.272544 °
				-121.246161 °	-121.246161 °
DWR ID	DWR_NA0015_63_t_2012_1				
Action/Comments					
Inspector Comments: All vegetation needs to be removed from the drop structure before winter.

Plumas Co. is scheduling removal of all vegetation from the channel.

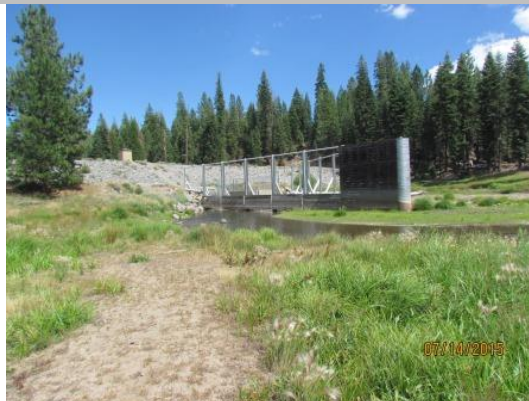
Photo 1 of 2 : ST_2016_NA0015_37_23_20160615_00007.jpg

View of the dam and structure. 2015

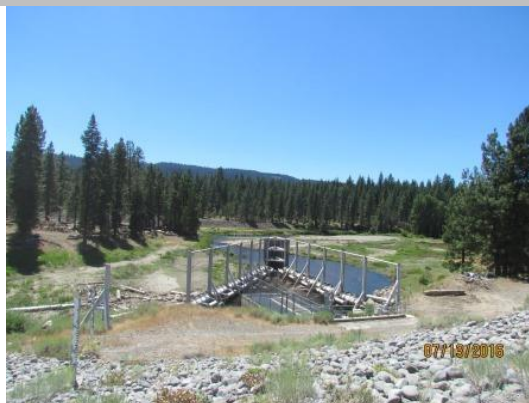
Photo 2 of 2 : ST_2016_NA0015_37_23_20160729_00012.jpg

View of the dam intake and debris diversion structure.

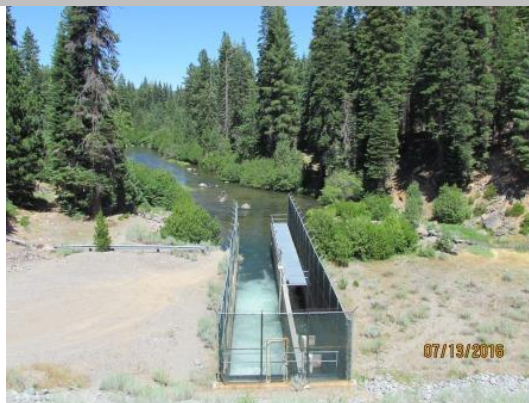
Photo 1 of 1 : ST_2016_NA0015_37_1_20160729_00009.jpg

LM Start	0.00	Rating **	A	Issue No.	1
LM End	0.00	Issue Type +	Ma	Location *	
Category	Structures & Concrete Lined Channels			GPS Latitude/Longitude	
				Start	End
Item	Vegetation & Obstructions			40.302834 °	40.302834 °
				-121.261901 °	-121.261901 °
DWR ID	DWR_NA0015_37_t_2012_1				
Action/Comments					
Inspector Comments: Remove all vegetation from the face of the dam area before winter.

View of the outfall structure and slope of the dam.

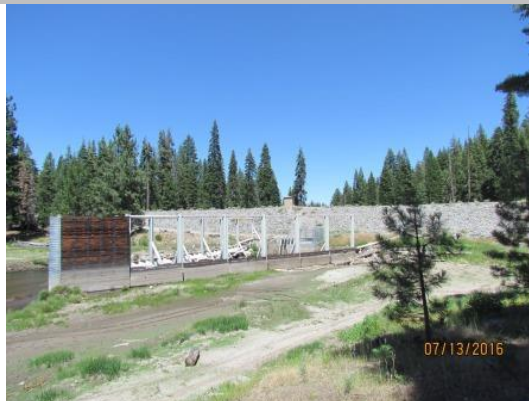
Photo 1 of 2 : ST_2016_NA0015_37_5_20160729_00010.jpg

LM Start	0.00	Rating **	A	Issue No.	5
LM End	0.00	Issue Type +	Ma	Location *	
Category	Structures & Concrete Lined Channels			GPS Latitude/Longitude	
				Start	End
Item	Encroachments			40.302834 °	40.302834 °
				-121.261901 °	-121.261901 °
DWR ID	DWR_NA0015_37_t_2012_5				
Action/Comments					
Inspector Comments: Plumas Co removed all debris this spring.

View of the debris diversion structure at the intake.

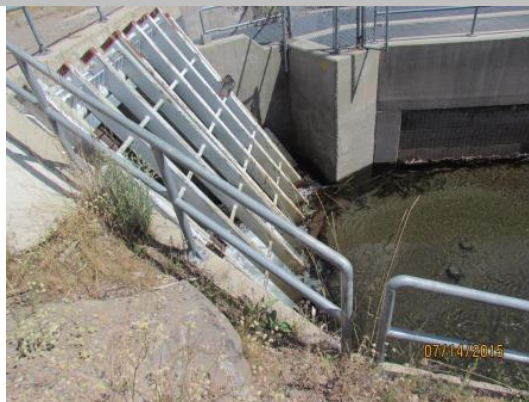
Photo 1 of 2 : ST_2016_NA0015_37_9_20160615_00003.jpg

LM Start	0.00	Rating **	A	Issue No.	9	
LM End	0.00	Issue Type +	Ma	Location *		
Category	Structures & Concrete Lined Channels			GPS Latitude/Longitude		
				Start		End
Item	Trash Racks			40.302834 °	40.302834 °	
				-121.261901 °	-121.261901 °	
DWR ID	DWR_NA0015_37_t_2012_9					
Action/Comments						
Inspector Comments: The debris has been removed from the trash rack.

Plumas Co. removed all debris from the trash rack.

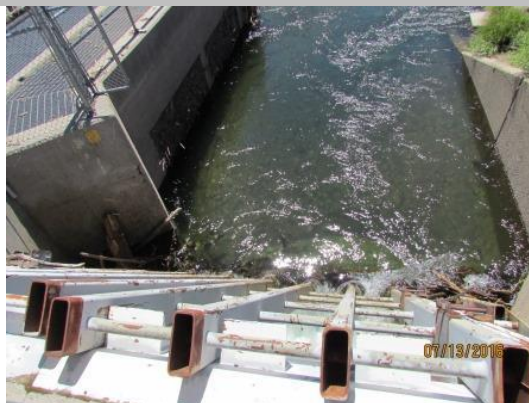
Photo 2 of 2 : ST_2016_NA0015_37_9_20160729_00011.jpg

LM Start	0.00	Rating **	A	Issue No.	9 (cont)	
LM End	0.00	Issue Type +	Ma	Location *		
Category	Structures & Concrete Lined Channels			GPS Latitude/Longitude		
				Start		End
Item	Trash Racks			40.302834 °		40.302834 °
				-121.261901 °		-121.261901 °
DWR ID	DWR_NA0015_37_t_2012_9					
Action/Comments						
Inspector Comments: The debris has been removed from the trash rack.

View of the clean trash rack.

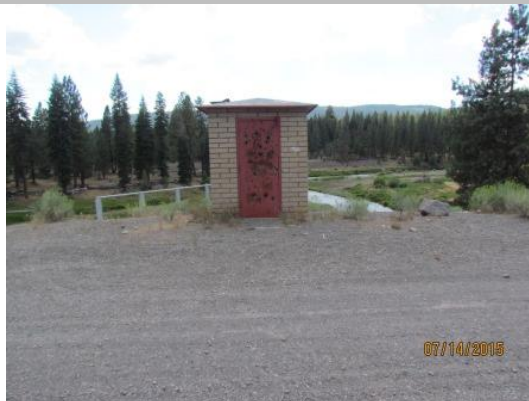
Photo 1 of 1 : ST_2016_NA0015_37_12_20160615_00005.jpg

Gauging house on top of the dam, use discontinued due to vandalism.

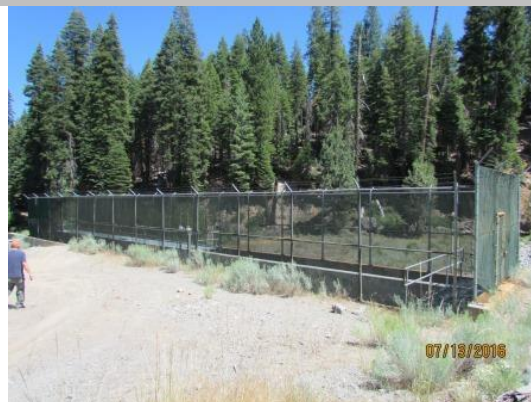
Photo 1 of 1 : ST_2016_NA0015_37_17_20160729_00013.jpg

LM Start	0.00	Rating **	A	Issue No.	17
LM End	0.00	Issue Type +	Ma	Location *	
Category	Structures & Concrete Lined Channels			GPS Latitude/Longitude	
				Start	End
Item	Security Fencing			40.302834 °	40.302834 °
				-121.261901 °	-121.261901 °
DWR ID	DWR_NA0015_37_t_2012_17				
Action/Comments					
Inspector Comments: Safety / security fence is in good condition.

View of the security fencing around the outfall.
